EXCAVATIONS ON THE ROMAN VILLA AT BEADLAM, YORKSHIRE

**YORKSHIRE
ARCHAEOLOGICAL
REPORT No 2.**

YORKSHIRE ARCHAEOLOGICAL REPORT No. 2
Yorkshire Archaeological Society, Roman Antiquities Section
1996

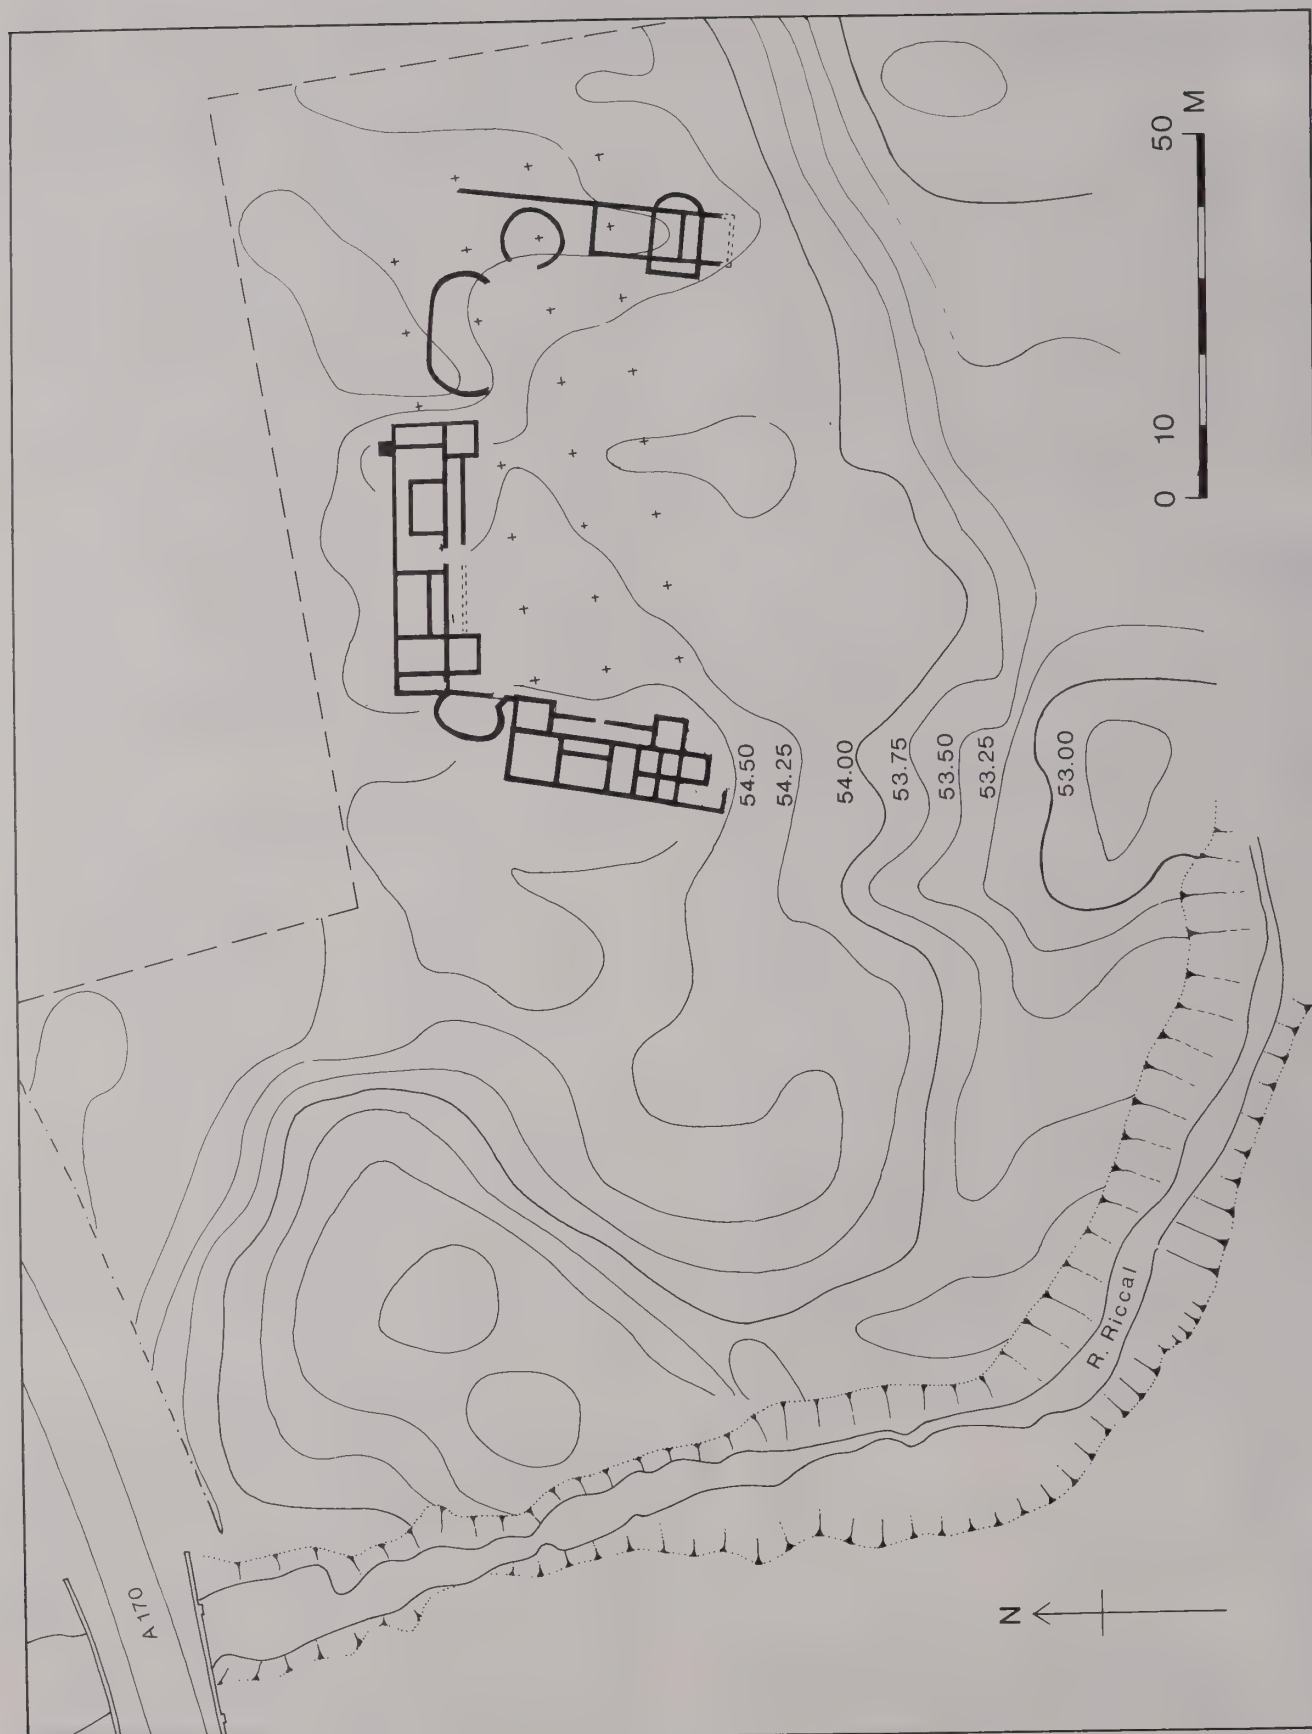
Fig. 2 Overall site plan in relation to contours and the River Riccal.

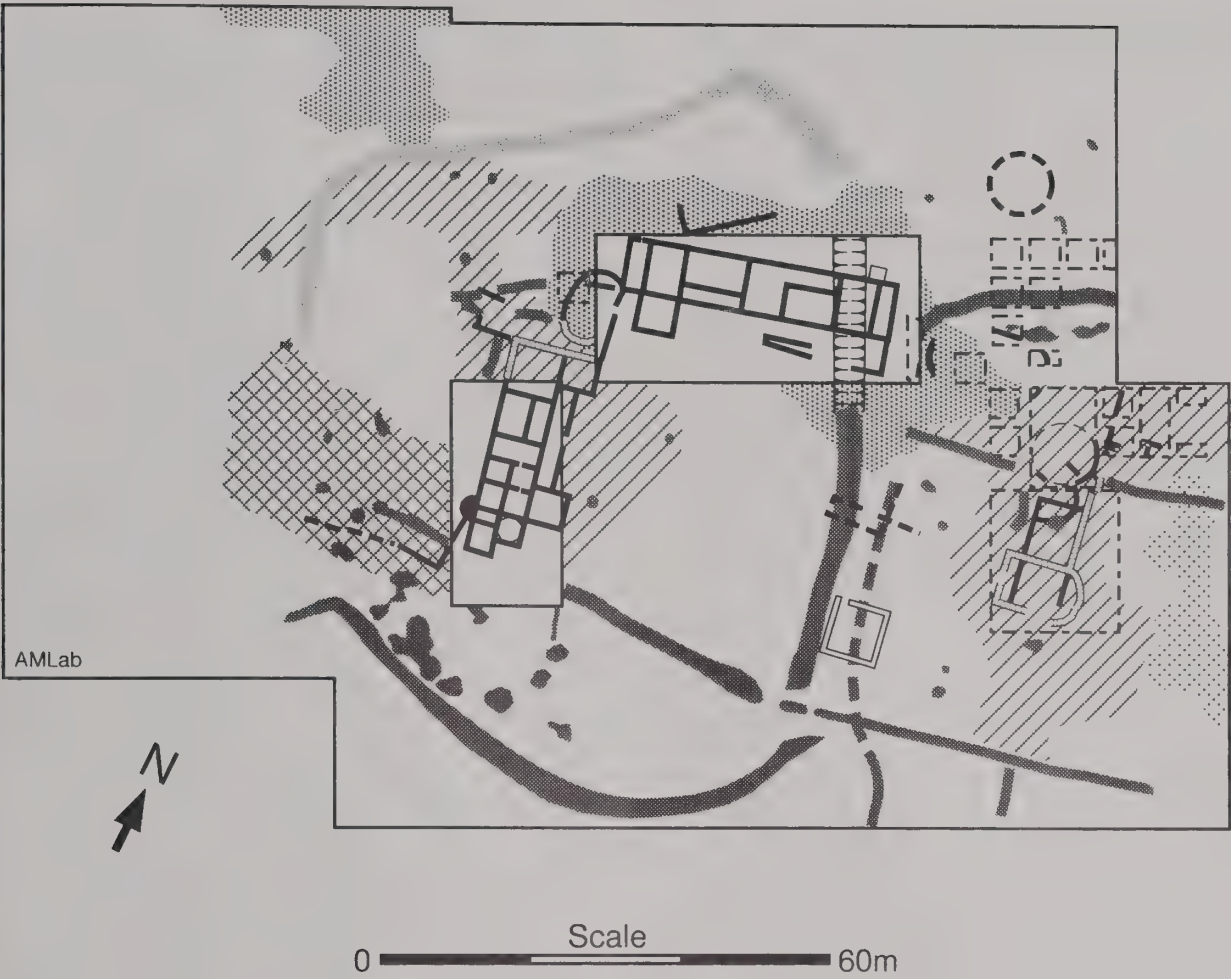
Fig. 6 Interpretation of geophysical surveys.

This structure is only known from its presence on the geophysical surveys (Figs. 5 and 6) but it appears to have measured approximately 7.50m square and to have been constructed on the eastern edge of the earlier enclosure ditch and with its west wall on the same alignment as the east side of Building 1. Its north wall was on the same alignment as the original south wall of Building 2. Twelve metres to the north another length of wall also shows on the surveys and is assumed to have been a boundary. This shared the same alignment as the north wall of Building 5. For further comment on this structure see the general discussion below.

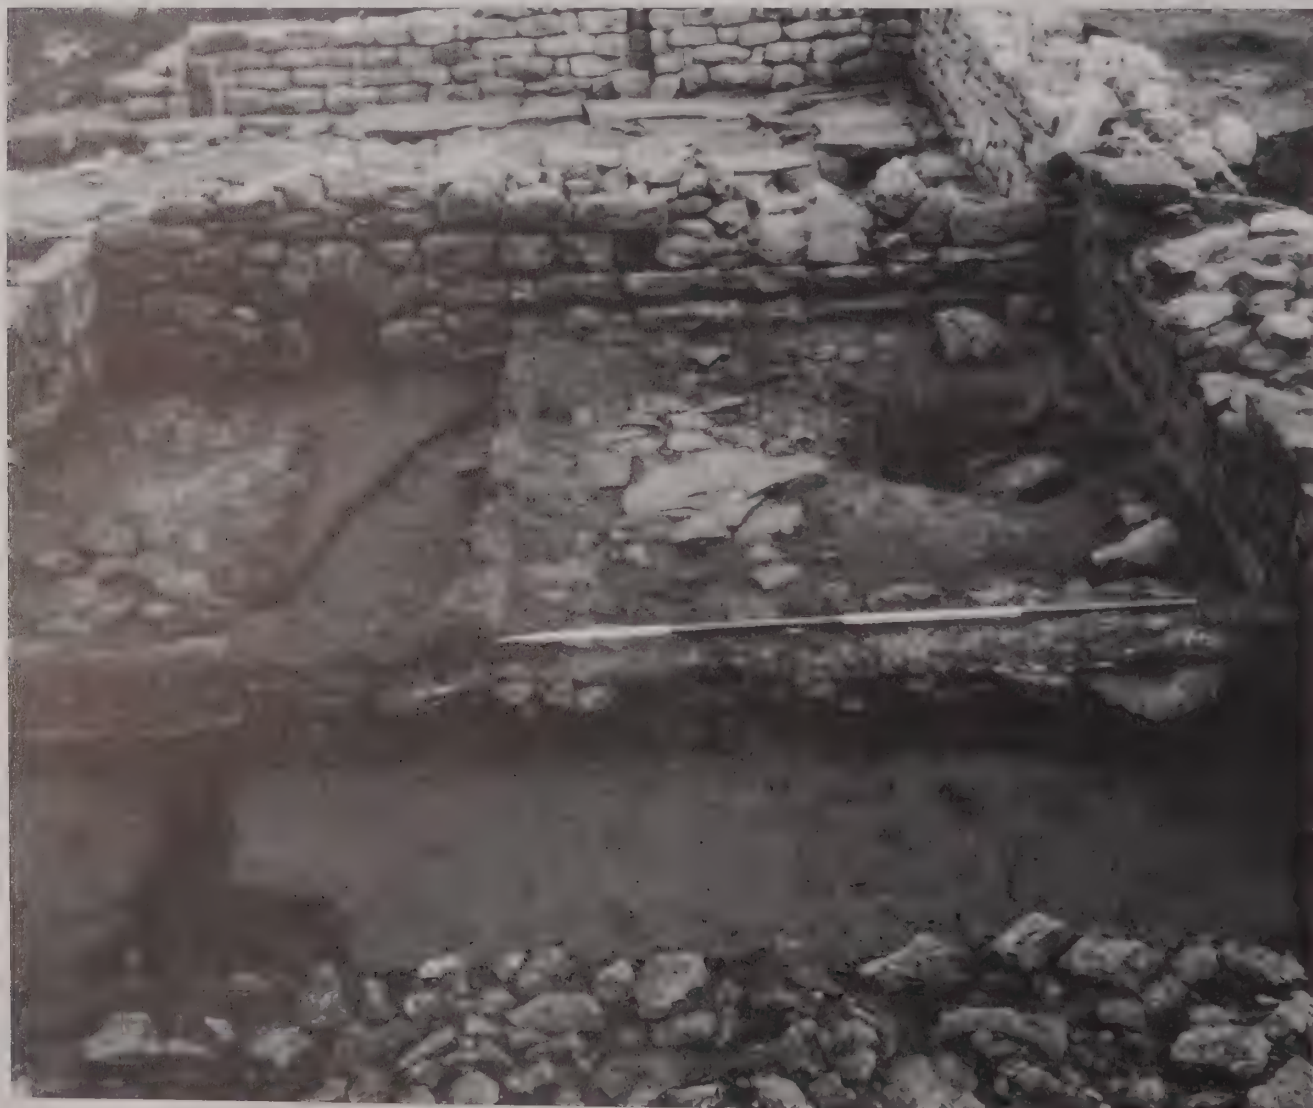
Fig. 8 Building 1, Room 6. View west showing earlier curved wall trench. The hypocaust furnace arch serving Room 7 can be seen in the nearer wall.

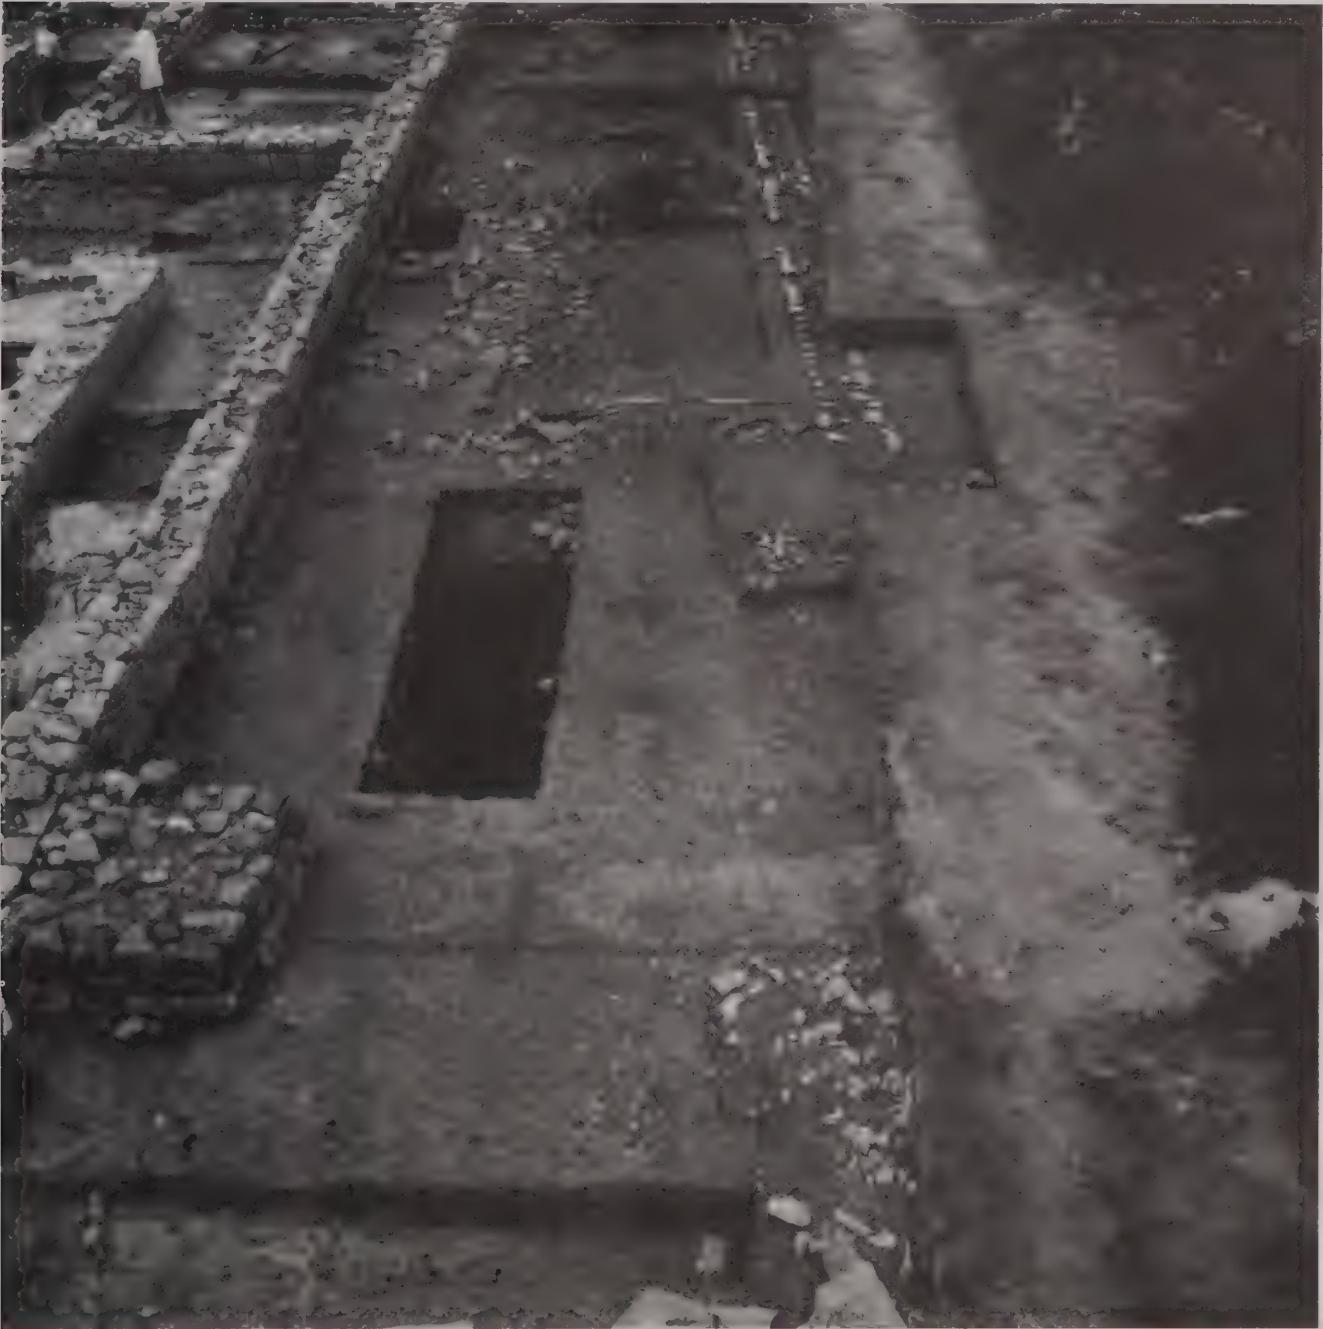
Fig. 9 View west showing trackway and boundary wall north of Building 1. The slit trench shows the location of the earlier enclosure ditch and to the bottom left is the possible external stair foundation on the north side of Room 1.

In 1976 the ditch was sectioned in two places, in Trench 4, Area BIX, north of Room 1 (Fig. 9) and to the south of Room 9, Building 1 where the ditch measured about 4.50m wide with a U-shaped profile about 1.25m deep (Fig. 7). Its lower filling contained Roman pottery of the Iron Age tradition overlain by deposits of clay possibly infilled from the

bank to create a causeway. The clay north of Room 1 was overlain with cobbles which possibly formed part of a cobbled track which ran east-west directly to the north of the later villa (Fig. 10). North of the track and parallel to it was a wall which the geophysical surveys appear to indicate may have replaced an earlier ditch and that the same ditch continued its alignment east of the enclosure. It is also probable that the supposed trackway was flanked on its south side by another ditch of two phases which shows on the surveys east of Building 1, on the same alignment as its north wall. An examination of Archive Photograph 41 shows a clay-filled anomaly adjacent to the north-east corner of Room 10 which might be the same feature. Also, in 1976, a trench cut parallel

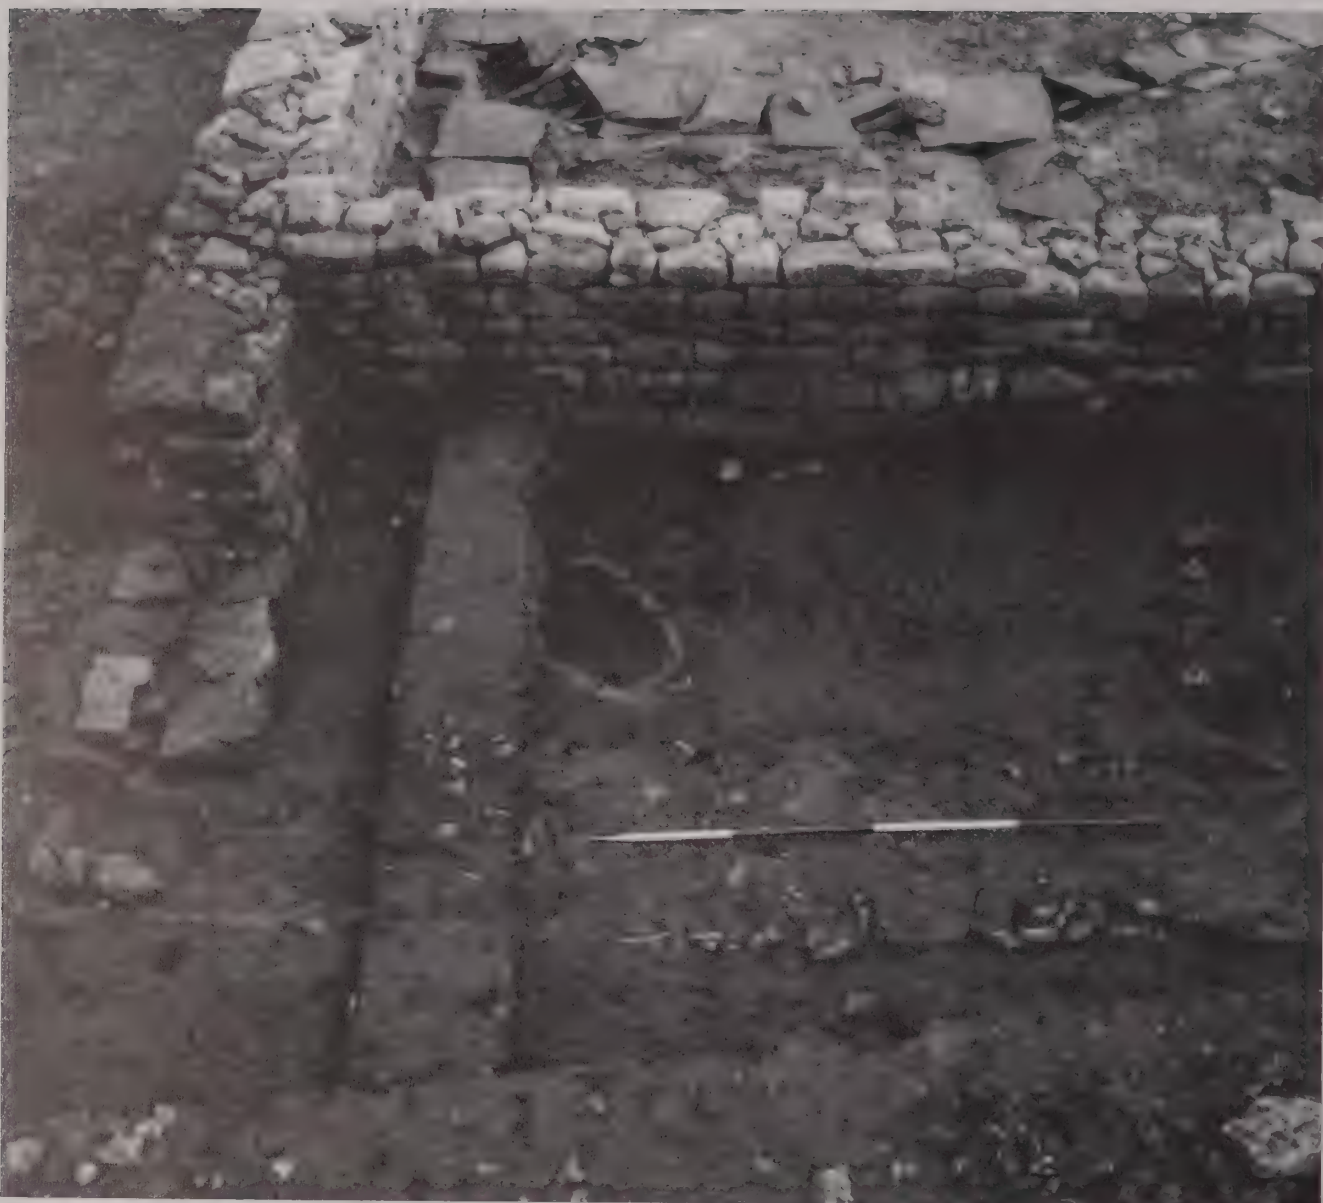
Fig. 11 Building 1, Room 12. View east showing butressed north wall and earlier oven

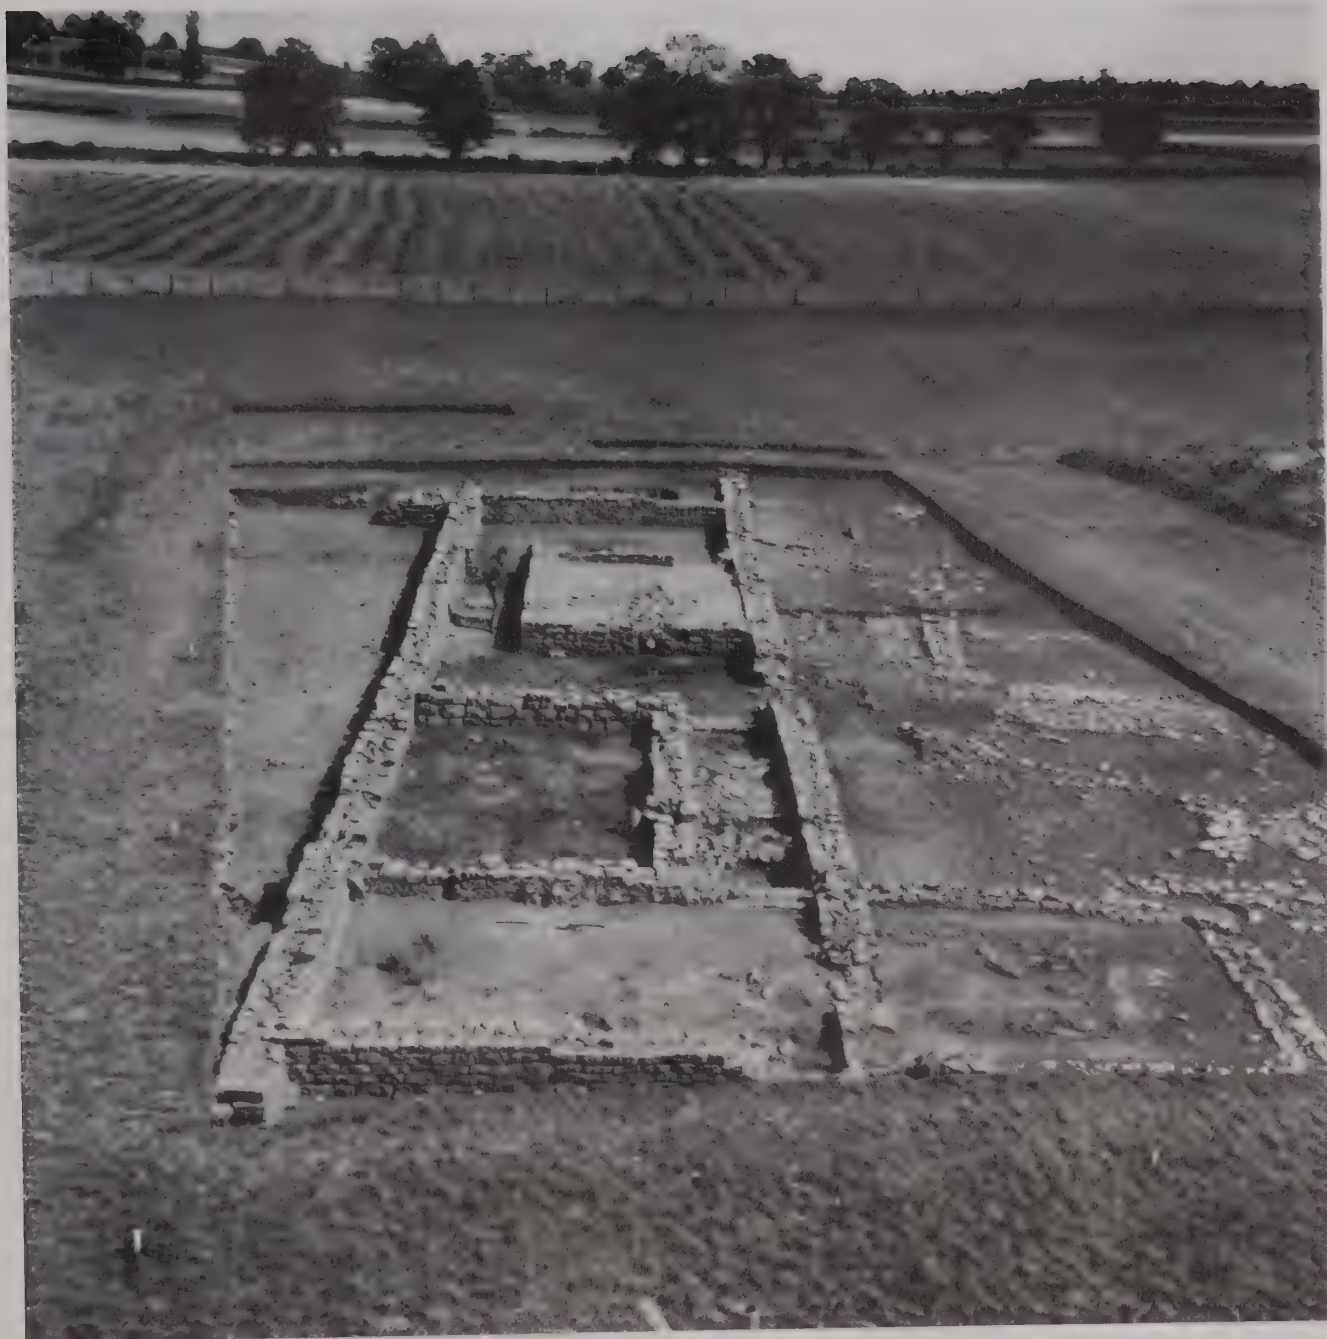
Fig. 12 Building 1, overall view looking east.

This occupied the eastern end of the building and measured 4.50m wide by 6.40m deep. Its west wall combined both tabular and pitched courses of masonry whereas the other three walls were of tabular construction throughout. For this reason it is possible to suggest that the west wall may have been a later insert and that the areas of Rooms 1, 2, 3 and 4 originally formed a large open room or barn. Its wall at the south-east corner had three neatly dressed quoins indicating that originally this was an external wall and that Room 10 to the east was a later build.

The main entrance was in the south wall; another entrance opened midway along the west wall, into the areas of Rooms

2, 3 and 4, but this was blocked at the time of the construction of Room 2 and the recess used for the insertion of a fireplace heating Room 1 (Fig. 13). Access into Room 2 was gained by two steps and a new doorway in the south-west corner of the room; another new doorway communicated with a passage, Room 3, in the north-west corner. The south entrance was blocked but whether this event took place contemporaneously with these alterations is not known. However, as a result of this blocking access was restricted to the entrances in the west wall.

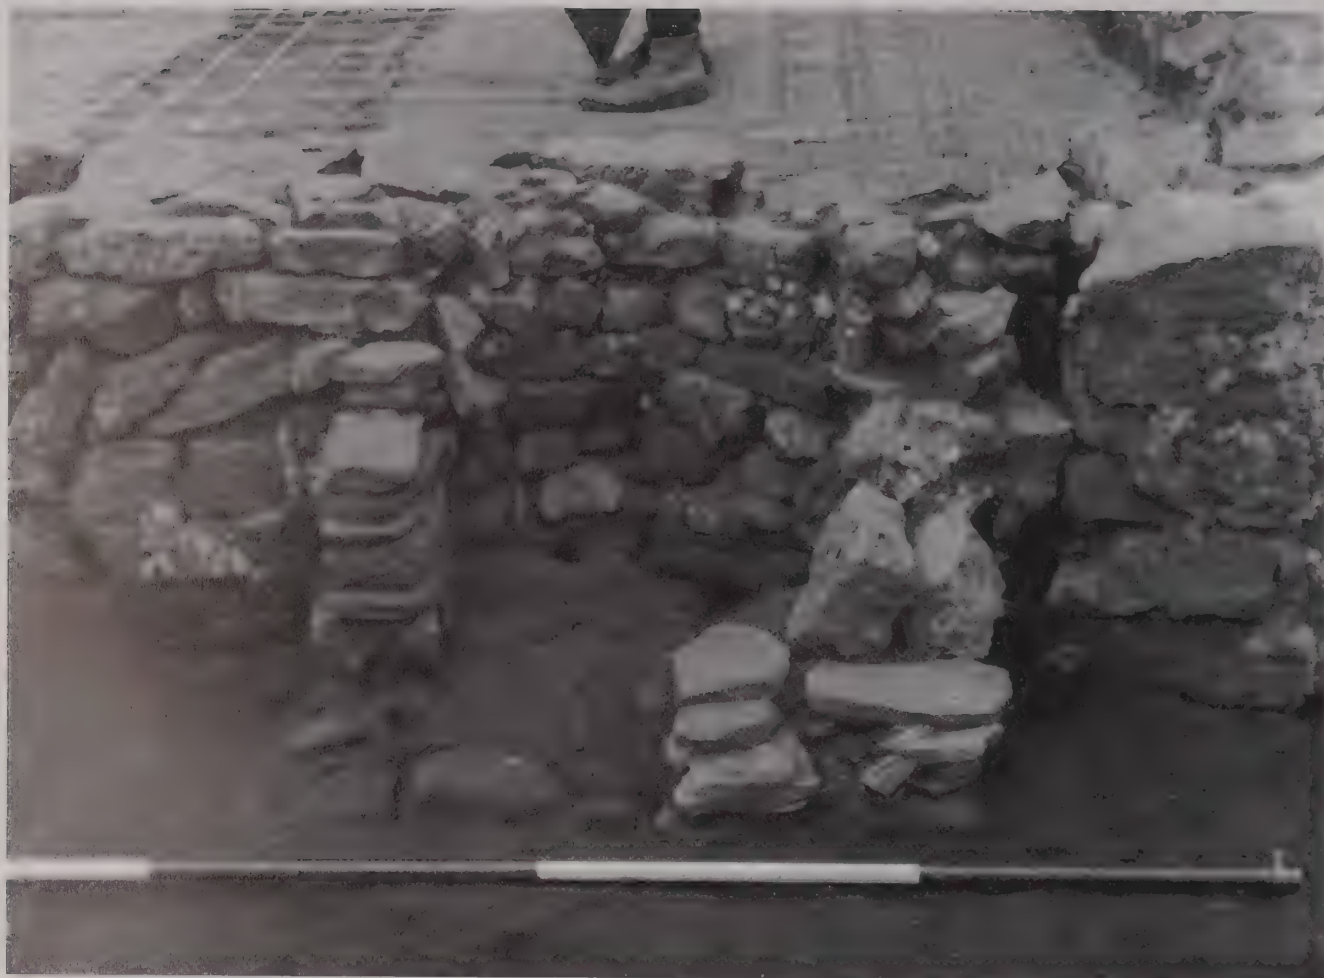
Fig. 13 Building 1, Room 1. Fireplace inserted into earlier entrance. View west.

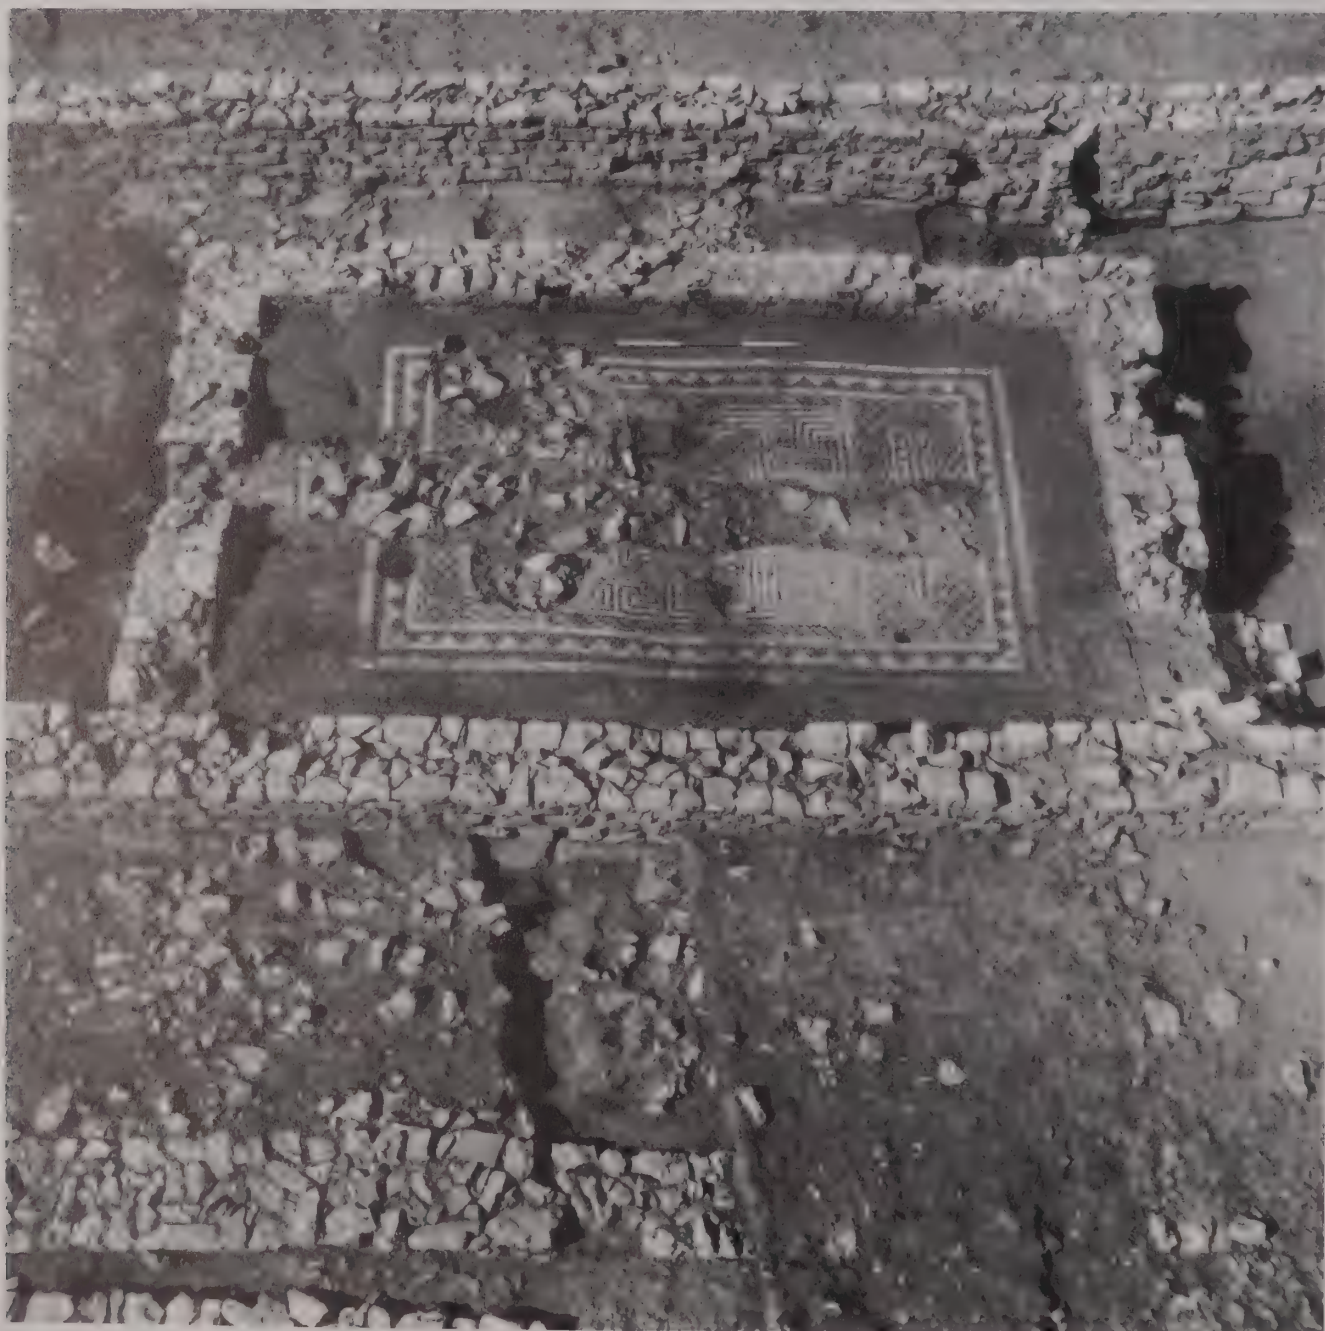
Fig. 16 Building 1, Room 2 showing the mosaic pavement cut by a corn drying oven. View north.

The mosaic had been patched with mortar in antiquity but was also badly scarred along its east-west axis and across its width on the west side. At first inspection this scar might seem to be the result of collapse of the cap-stones into the underlying flues but this is unlikely since the scar was also associated with four post-holes at the angles where the main east-west and north-south flues crossed. The missing cap-stones appear to have been carefully removed, leaving the channel walls intact, and therefore a possible explanation is that the underlying furnace was modified into a corn-drying or malting oven and that the post-holes held part of its superstructure.

When the mosaic was lifted and part of the underlying hypocaust examined evidence for a north-south foundation was found. It is represented on a single overall plan of the site but not on any detailed excavation drawings or notes. Its alignment coincides with a line of rubble possibly filling an earlier ditch or gully north of the building and shown on archive plan No. 15. Possibly it represents part of the same feature and in the circumstances has not been included as a positive feature in this report although it is possible it was a wall associated with the earlier enclosure walls already described. Found on the floor were fragments of a decorated bone comb (Fig. 33, No. 26). It would appear to be of late fourth-fifth-century date and may have been lost when the room was being used for corn drying or malting. No coins were found here.

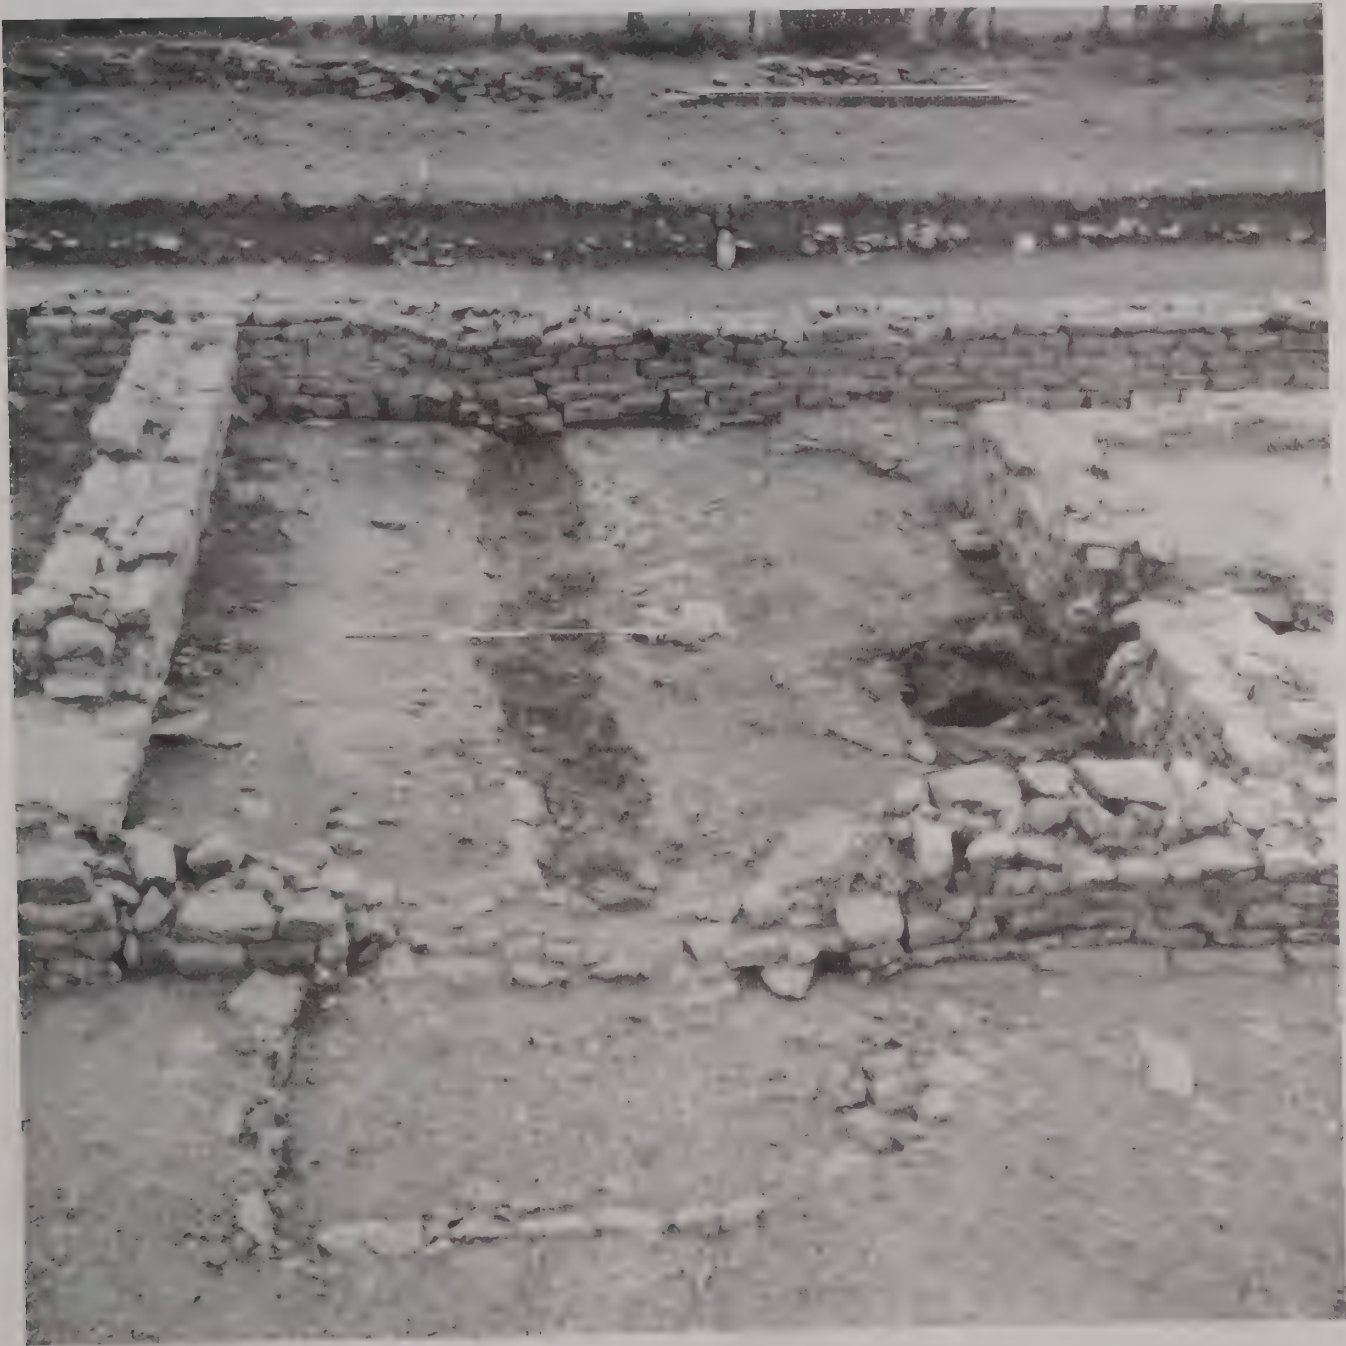
Fig. 17 Building 1, Room 4. Overall view north showing foundation across room.

Running north-south across the room, cutting the clay floor, was a trench filled with grey blue clay and cobbles similar to the foundations of some of the walls of the buildings. The trench continued south beyond the building, cutting the incoming cobbled path leading towards Room 4 and demonstrates, therefore, that the feature is later. At the time of the first excavations in 1969 the feature was interpreted as a drain, which, south of the building it appears to have been since there were stones set on edge against its sides. Re-examination in later seasons cast doubt on this interpretation; it was then reinterpreted as a robber trench since no trace of any drain-like structure was encountered in the sections excavated within the building. At the north end the north wall of the building had faulted and subsided into the trench. If it was a drain, possibly it was built to collect rainwater from the north side of the building; the ground levels were slightly higher here and damp may have been a problem (for further discussion on this feature see p. 41). In a subsequent phase it was infilled and sealed by a thick black deposit which contained 19 coins, 10 of which were found in the hollow created by subsidence of the trench. Found close to the entrance was a fine copper-alloy nail cleaner decorated with a fish (LB/OW, Fig. 28, No. 2).

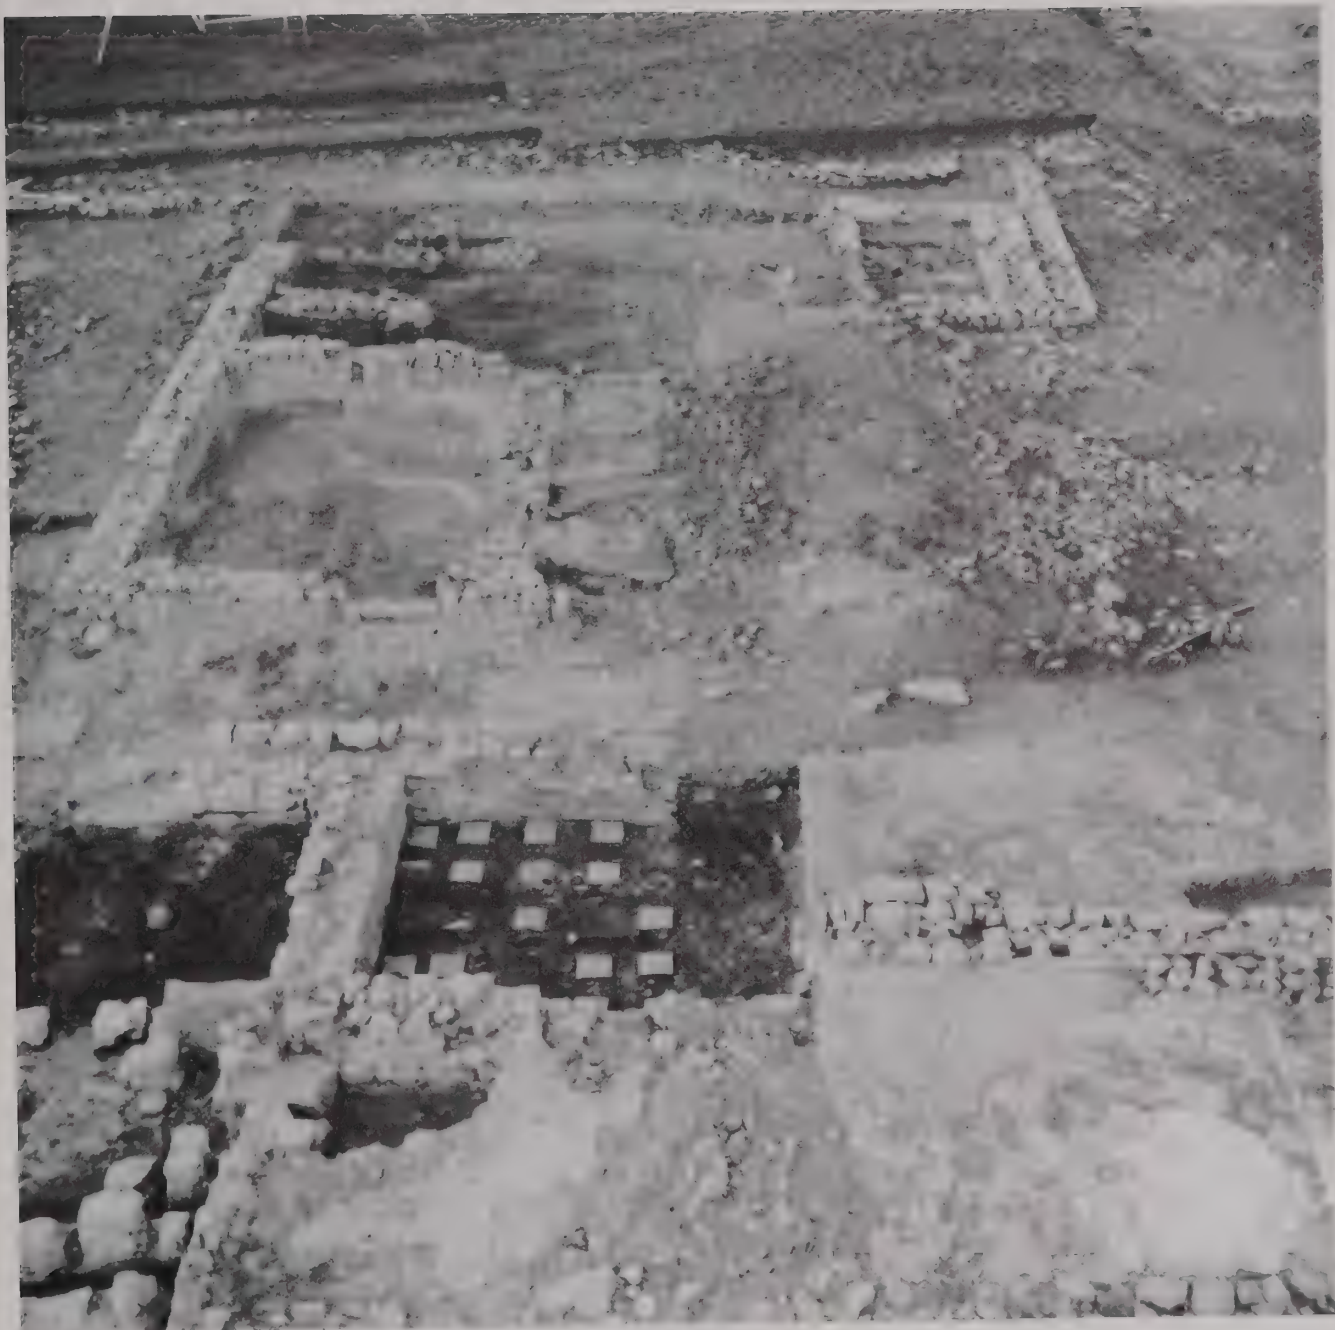
Fig. 21 Building 2, overall view looking north.

Building 2 was first located in trial trenches in 1966 and fully excavated in 1969; it shared the same depth constraints imposed on the excavation of Building 1 and, therefore, earlier levels were not investigated. The north-east corner of the building lay about 5.25m south-west of Building 1 with its east side in line with the west wall of Room 12. As with Building 1, it was of winged-corridor plan with a main block of rooms with east projecting wing-rooms linked by a corridor or verandah facing onto the courtyard. The south end of the building incorporated a bath-suite (Fig. 21) which was later extended south; the original length of the building was 23.40m and its overall width 12.40m. An immediate observation is that its plan is more typical of the standard winged-corridor villa than Building 1 and if it were not for the status indicated by the presence of the mosaic in Building 1 with its south-

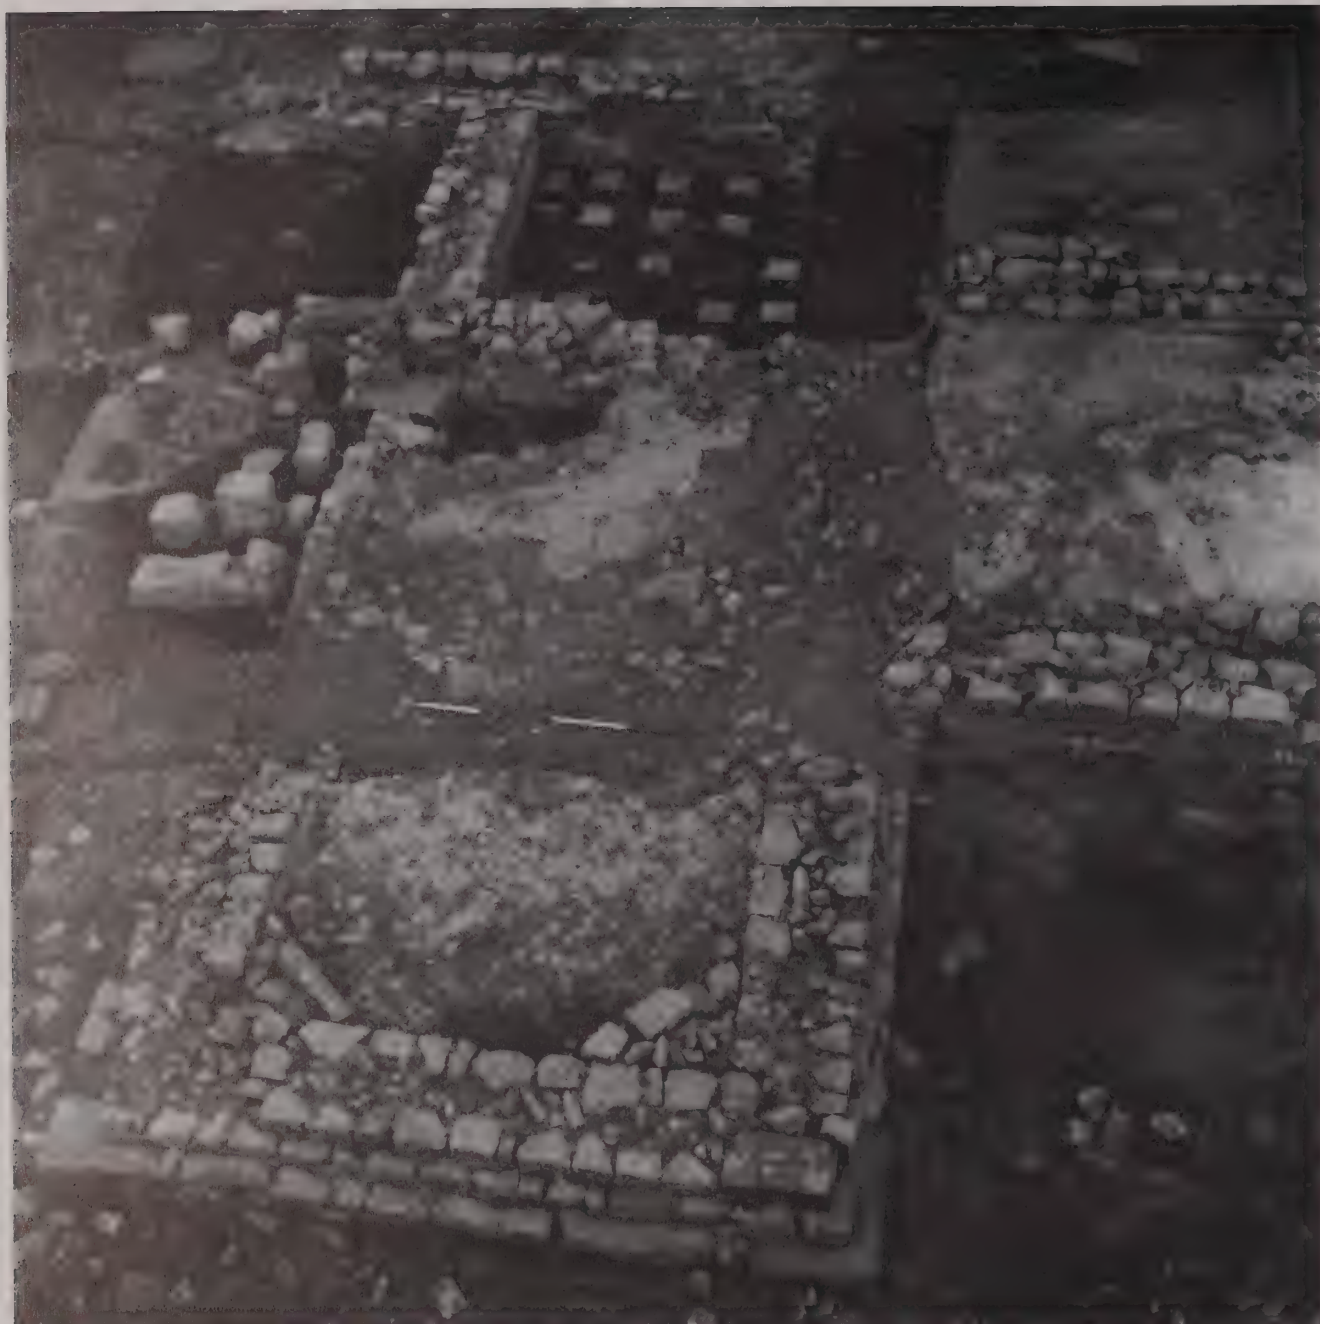
Fig. 22 *Building 2, the bath-suite. View north.*

Room 3 was constructed against the south wall of Room 2. It was a plunge-bath and almost certainly a later addition to the bath-suite. Its foundations had a double offset. Inside, the angles of the walls had diagonal benches resulting in the actual plunge-bath being octagonal (the diagonal benches on the north side were largely destroyed but sufficient survived to demonstrate their existence originally). The walls were once lined with *opus signinum*; found amongst the rubble in the south-east corner was a large fragment that lined the surface of the bench since its shape reflects the angle of the seat and the wall. It had two layers of plaster which suggests that the bath may have suffered the same problems as the larger plunge

in Room 1 and required resealing. A bench or step must have separated the bath from Room 2; a similar arrangement to that postulated between Rooms 1 and 2. A stone drain from Room 2 was discovered beneath the floor but the actual drain for the plunge-bath was towards the south-west corner where a hole for a lead pipe was found; it probably flowed into the existing drain since this outlet was retained, as evidenced by the way the foundations for the plunge-bath were carefully bridged over it (Fig. 23).

Room 3 (Fig. 22)

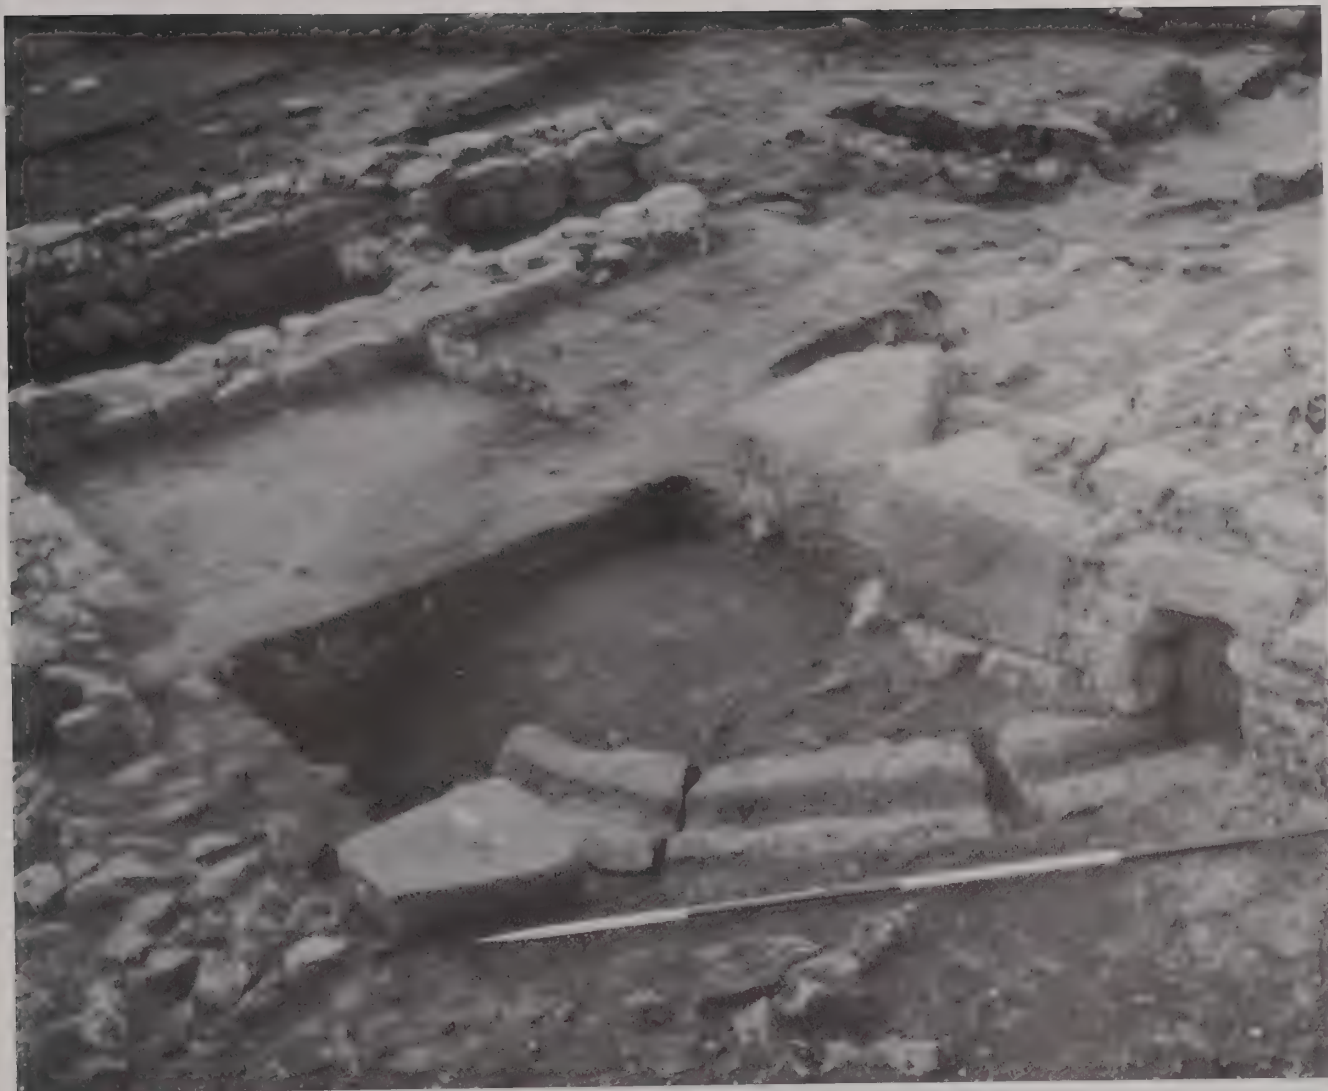
Fig. 23 Building 2, the plunge-bath, Room 3, with drain on south side. View north-west.
